THE SPINDLE DEFECT EVALUATION USING A THREE-DIMENSIONAL VIBRATION ANALYSIS

Abstract: In this paper, accelerometers transducer are used to check the spindle vibration. Once the spindle is out of balance, the transducer gives a dialog response to computerized numerical controller (CNC) which is set with a control level. This paper aims at analyzing the state of the machine tools and data detection due to vibration-shaft electric motor assembly (Fig. 2). A series of measurements are performed in order to determine the cause of the vibration generator and highlighting effects. To determine the source of vibration is used a number of tools and techniques based on signal processing. Such vibration analysis in this paper is based on a number of methods, such as spectrum frequency, harmonic order, and trend signal. The linking part between the transmission belt and the main spindle was measured and as a result, it was observed that the elastic part doesn't work accordingly and that it represents the cause of the 4th order harmonic.

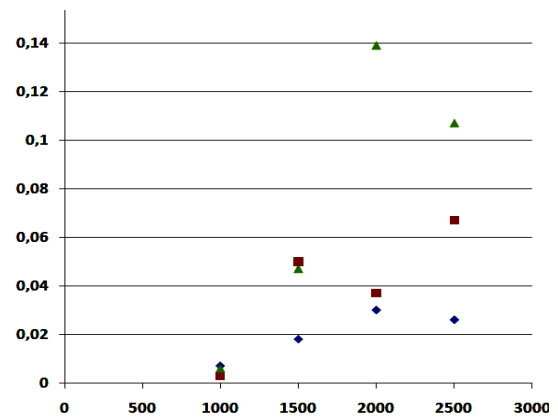
Fig. 4. Vibration level vs. rotational speed, with tool:

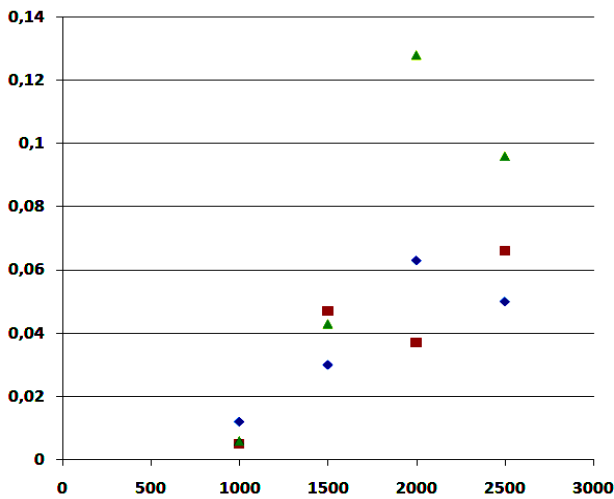
Fig. 5. Vibration level vs. rotational speed, without tool:
 ◆ X axis; ■ Y axis; ▲ Z axis.

In Fig. 5 one can observe that the vibration level for the machine tool configuration without tool is greater than in the case of the configuration with tool. Therefore, as the level of vibrations increases, it is safe to say that the tool cannot be the cause of vibrations. Further analysis will concentrate on the configuration grinding machine without tool.

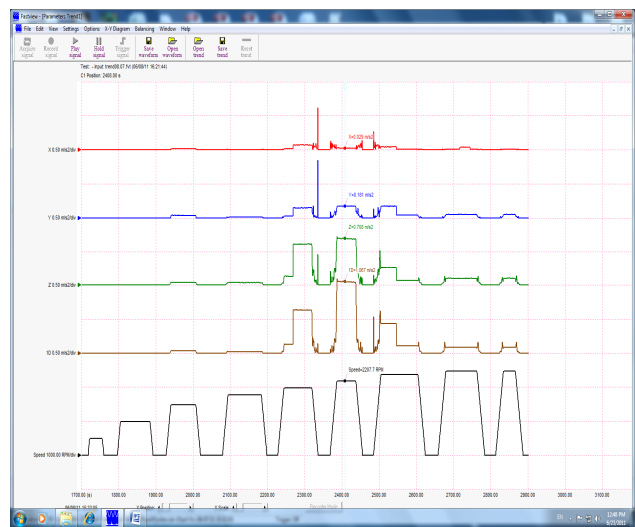
Figure 7 represents the increase of vibration amplitude with the increase of the main spindle rotational speed. The increase of rotational speed is registered by the laser tachometer as an electrical impulse, as shown in figure. Above it, the increasing vibrations are registered with the two mentioned accelerometers (3D and 1D).

Fig. 7. Evolution of vibrations with rotational speed of main spindle.

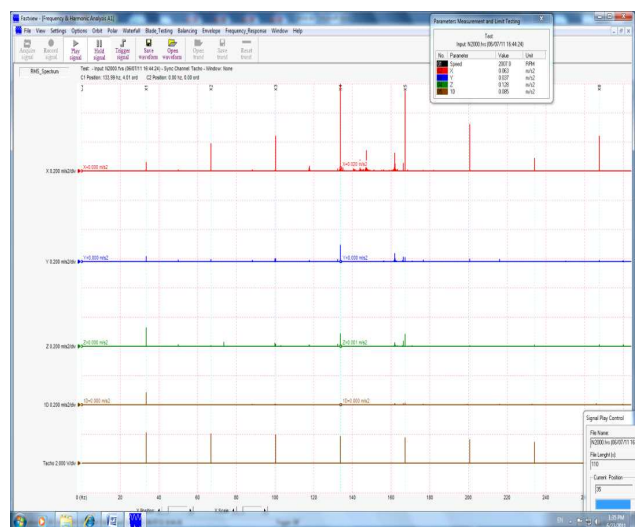
By applying the Fast Fourier Transform the frequency spectra of vibration was obtained (Fig. 8). The first peak on the diagram shows the rotational frequency. As the measurements were conducted at a speed of 2 000 rpm and considering the formula below (1), the value of the rotational frequency is 33.3 Hz.

As shown in Fig. 8, the amplitude increases a lot at the frequency of 133.8 Hz, corresponding to the 4th order harmonic.

Fig. 8. Frequency spectra for spindle speed $n = 2\,000$ rpm.

Figures 8 and 9 also indicate, with lot smaller amplitudes, an unbalance by the presence of the first order frequency (rotational frequency) and a misalignment materialized by 2nd and 3rd harmonic orders.

The result of the conducted analysis is that the vibration problem is caused by the 4th order harmonic. This 4th order harmonic is rarely present in vibration spectra and it could be considered as a misalignment.

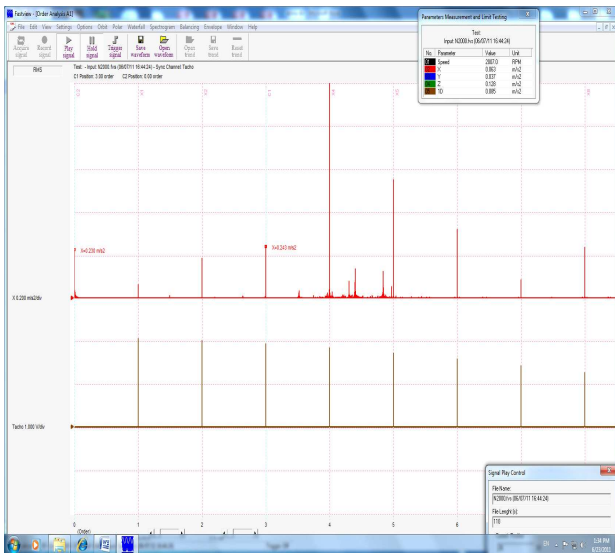
For a thorough result, an order analysis is used for verification (Fig. 9). As it can be seen, the 4th harmonic points out itself, with obvious high amplitude.

Fig. 9. Order analysis for spindle speed $n = 2\ 000$ rpm.

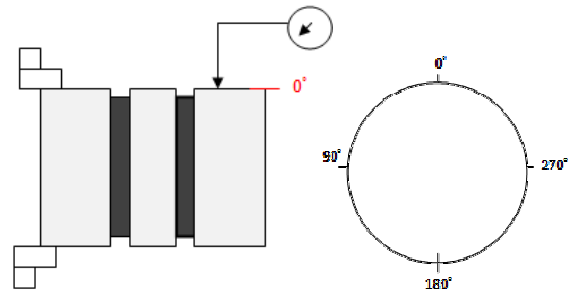
Considering the functionality of the assembling part, circularity measurements were made for it also (Fig. 12). The measurements were done at the exterior, as at the interior of the part, for both rings. The values obtained from the measurement are centralized in Table 2. It is easy to observe that the circularities are very high.

As conclusion following the measurements, a clamping defect was discovered for the assembling part, respectively a four points contact defect.

Fig. 12. Circularity measurements.

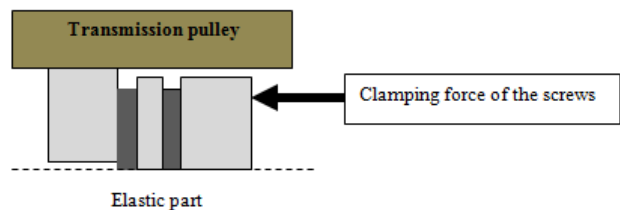
Figs. 13 and 14 represent the assembly of the elastic mechanical part with the transmission pulley and with the main spindle and shows the defect at montage. At the exterior of the part, only one ring is in contact with the transmission pulley, and at the interior, one of the rings doesn't have the correct angle for assembling, thus the high level of vibrations that occurs during functioning are higher speeds.

Fig. 13. Inappropriate assembly of elastic part and transmission pulley.

The linking part between the transmission belt and the main spindle was measured and as a result, it was observed that the elastic part doesn't work accordingly and that it represents the cause of the 4th order harmonic. As recommendation, the linking part should be replaced, or better, the transmission belt/main spindle assembling solution should be changed.

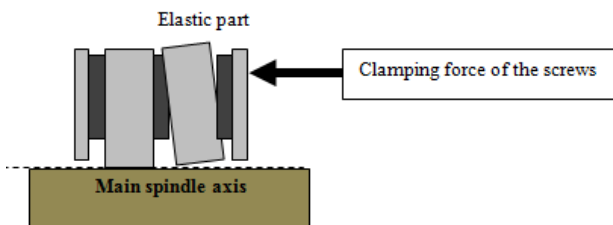
Fig. 14. Inappropriate assembly of elastic part and main spindle.
