## DEGRADATION OF THE SHAFT SURFACE DURING MACHINING TECHNOLOGY

**Abstract:** Estimation of structures life and ensure their safety and integrity is an essential part of the design of equipment for transport, engineering and other industries. Usually, fatal accident occurs often under varying loads without causing changes shape. Application of fracture mechanics and testing is possible to describe the propagation of cracks but the kinetics of damage in the early stages has not yet been expressed. The paper deals with identifying the causes of surface failure of a shaft made of material 42CrMoS4. On the basis of microstructural analysis completed by hardness testing, the occurrence of undesirable phases, such as non-metallic inclusions in the structure of the shaft, can be demonstrated. In the presence of various heterogeneous phases in the material structure, plucking of particles can occur during chip machining which leads to surface damage. In the conclusion, the authors recommend checking the starting material, which can eliminate problems that cause the degradation of the surface of the shaft. The failure of the surface causes the notch effect which initiates further failures

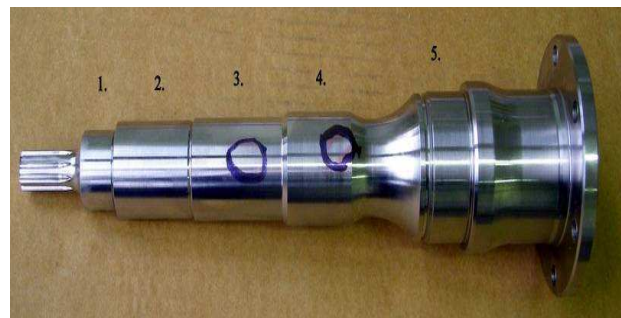
Fig. 2. Damage to the shaft before further processing and hardness measurement points (1–5).

Measurement of the hardness of the basic material along the entire length of the shaft was carried out according to Brinell –  $HB_{5/750}$ , the measurement results are shown in Table 3, and individual measurement points are indicated in Fig. 2 (1–5). The average hardness with the measurement standard deviation is  $HB_{5/750} = 302.4 \pm 11.3$ . The HMS 142 standard requires the specified hardness  $HB_{5/750} = 290-327$  for shafts made of material 42CrMoS4.

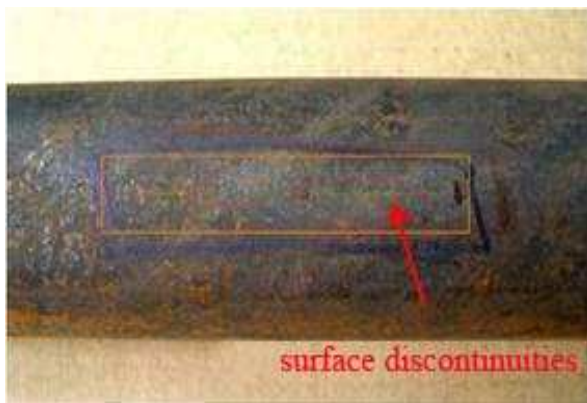
Based on the nature of the shaft defect identified by the crack detection, attention was paid to the starting material of the shaft. We used six semi-finished products from which cross sections were cut for the evaluation of microcleanliness after cutting from bar stock [7]. On their surface macroscopical discontinuities were identified in one case, Fig. 3, which were marked for metallographic analysis sampling.

**Fig. 3.** Starting material – surface discontinuities.

The first step of the experimental process was the assessment of the basic material from which the shafts are manufactured. The starting material showed the occurrence of discontinuities which were subjected to metallographic analysis [3], Fig. 3.

Microcleanliness rating revealed the presence of non-metallic inclusions in the central region and below the surface. From the macroscopically observed imperfections (scratches, cracks) of the shaft, see Fig. 3, cross sections were cut off to specify the kind of internal damage in detail. Occurrence of cracks was identified on the cross-section of a metallographic pattern; they were accompanied by oxidic phases, Figs. 4 and 5. The length of the crack was 0.135 mm and its depth 0.12 mm. Also a micro-overlap of depth 0.026 mm was identified below the surface.
