THE SPINDLE DEFECT EVALUATION USING A THREE-DIMENSIONAL VIBRATION ANALYSIS

Abstract: In this paper, accelerometers transducer are used to check the spindle vibration. Once the spindle is out of balance, the transducer gives a dialog response to computerized numerical controller (CNC) which is set with a control level. This paper aims at analyzing the state of the machine tools and data detection due to vibration-shaft electric motor assembly (Fig. 2). A series of measurements are performed in order to determine the cause of the vibration generator and highlighting effects. To determine the source of vibration is used a number of tools and techniques based on signal processing. Such vibration analysis in this paper is based on a number of methods, such as spectrum frequency, harmonic order, and trend signal. The linking part between the transmission belt and the main spindle was measured and as a result, it was observed that the elastic part doesn't work accordingly and that it represents the cause of the 4th order harmonic.

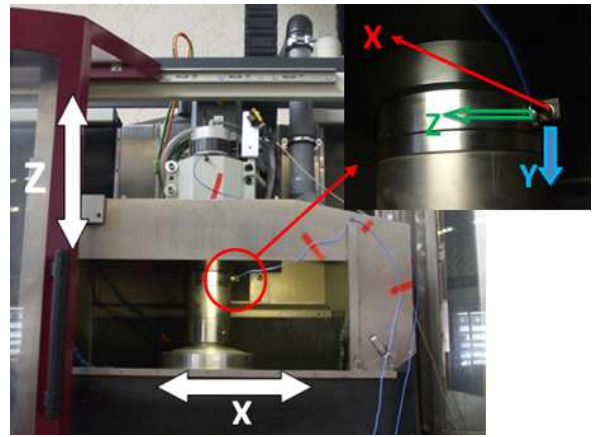
Fig. 3. Experimental setup for vibration measurements (axes of the machine tool and of the 3D accelerometer).

For the dynamic analysis, it was developed an experimental protocol [9] consisting of (Fig. 3): the grinding machine tool, the vibration measuring equipment – DSA 550 and the acquisition board NI 4432 from National Instruments, a triaxial (3D) accelerometer, which was fixed on the main spindle (on the bearings in proxi-

imity of the tool) and an uniaxial (1D) accelerometer mounted on the back bearing of the spindle, both used for measuring the accelerations for the vibration signal, and a laser tachometer for direct measuring of the spindle rotational speed, by converting the speed in an electrical signal.

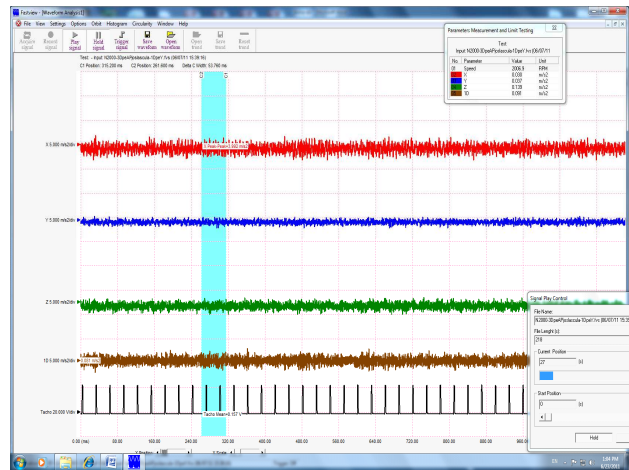
Fig. 6. Time signal for rotational speed $n = 2\,000$ rpm.

In Fig. 6 the waveform of the vibration signal is represented. The first free signals come from the tri-axial accelerometer on the three axes (X, Y and Z), the fourth signal is registered from the laser tachometer and the last signal represents the uni-axial accelerometer.

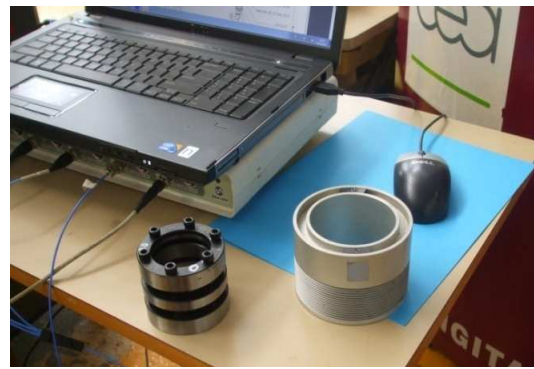
Fig. 10. The assembling part and the transmission pulley.

The electric motor/transmission belt/pulley/main spindle assembly revealed also the presence of an elastic mechanical part (Figs. 10 and 11).

As conclusion following the measurements, a clamping defect was discovered for the assembling part, respectively a four points contact defect.

Figs. 13 and 14 represent the assembly of the elastic mechanical part with the transmission pulley and with the main spindle and shows the defect at montage. At the exterior of the part, only one ring is in contact with the transmission pulley, and at the interior, one of the rings doesn't have the correct angle for assembling, thus the high level of vibrations that occurs during functioning are higher speeds.

The linking part between the transmission belt and the main spindle was measured and as a result, it was observed that the elastic part doesn't work accordingly and that it represents the cause of the 4th order harmonic. As recommendation, the linking part should be replaced, or better, the transmission belt/main spindle assembling solution should be changed.
